138 Verona  
Goleta  
Ca CA 93117

3/30/2024

HouseMaster

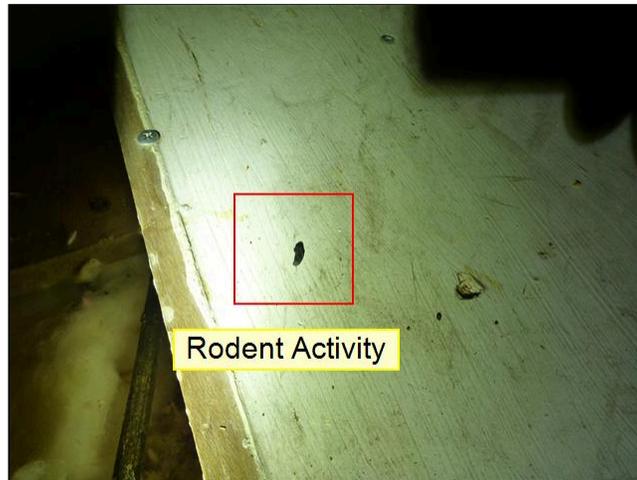
5.0 ROOF FRAMING (See Picture(s))

●											<p><b>5.0 ROOF FRAMING</b></p> <p>Rodent activity noted in the attic. Consult a pest control professional for evaluation and remediation as required. (See Picture(s))</p> <p>No structural conditions to report in attic. See pest control report for conditions related to wood framing members.</p>
●											<p><b>5.1 ROOF DECK / SHEATHING</b></p>
●											<p><b>5.2 VENTILATION PROVISIONS</b></p>
●											<p><b>5.3 INSULATION</b></p>

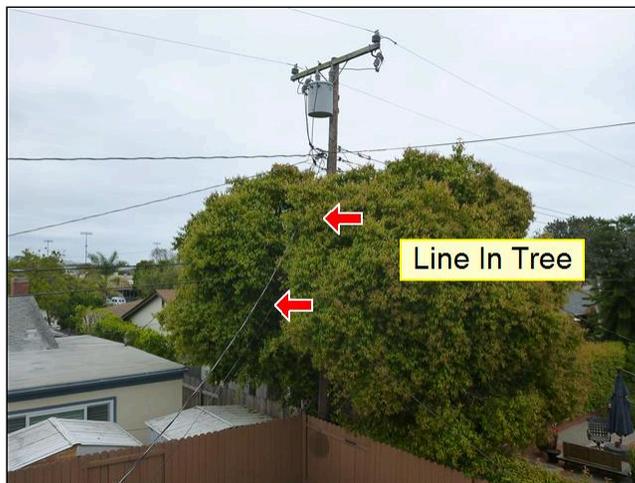
9.0 SERVICE / ENTRANCE LINE (See Picture(s))

●					<p><b>9.0 SERVICE / ENTRANCE LINE</b> Service wires are in tree and may be damaged by branches. Consult utility company to trim branches away from service wires to prevent damage.(See Picture(s))</p>
●					<p><b>9.1 SERVICE GROUNDING PROVISIONS</b></p>
	●				<p><b>9.2 DISTRIBUTION PANEL</b> Labeling of service panel breakers is required for safe operation.(See Picture(s))</p>
●					<p><b>9.3 MAIN DISCONNECT(S)</b> Consider installation of a whole house surge protector as an upgrade (not required by code) in main panel to protect sensitive electrical components. Consult an electrician for installation if desired.</p>
●					<p><b>9.4 DEVICES</b></p>
	●				<p><b>9.5 WIRING / CONDUCTORS</b> Open junction boxes with exposed wiring noted in attic. Add cover plates at any/all open junction boxes and/or properly terminate wiring for proper and safe installation.(See Picture(s))</p>

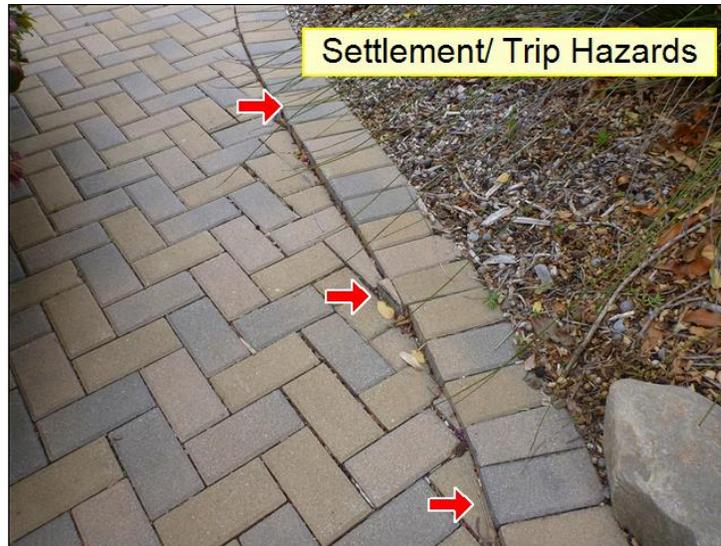
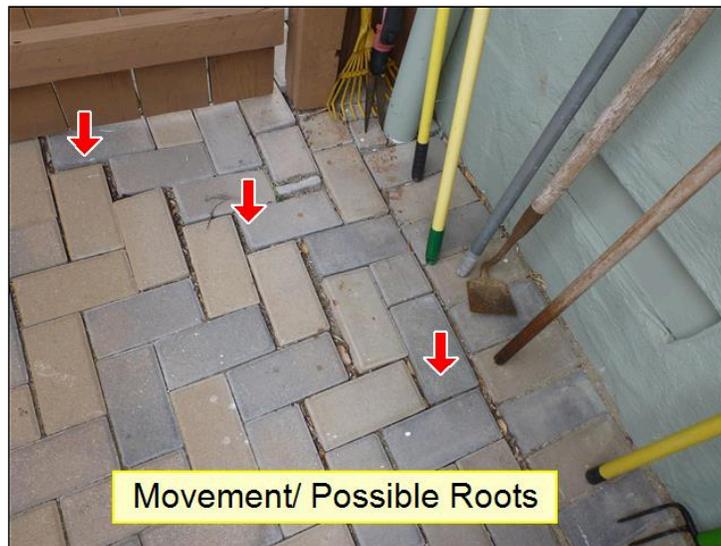
3.0 (See Picture(s))

Settlement/ movement noted. Tree removal may be needed to prevent further damage from tree roots. Consult an arborist for tree removal cost estimates as desired.(See Picture(s))

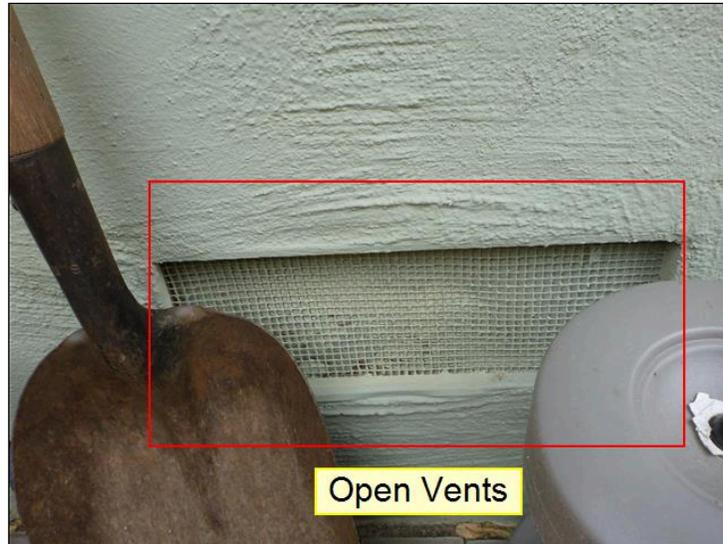
4.3 (See Picture(s))

Open blocked garage vent for proper combustion air provision to gas burning appliances in garage and venting of vehicle exhaust and install screen to prevent pest intrusion.(See Picture(s))

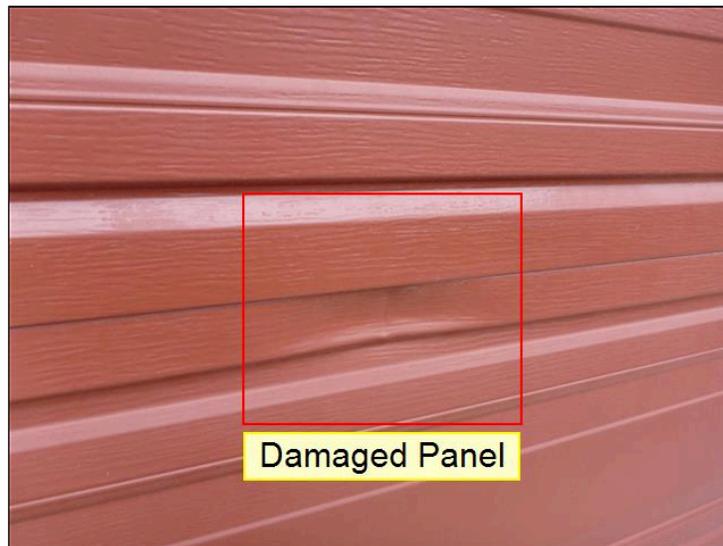
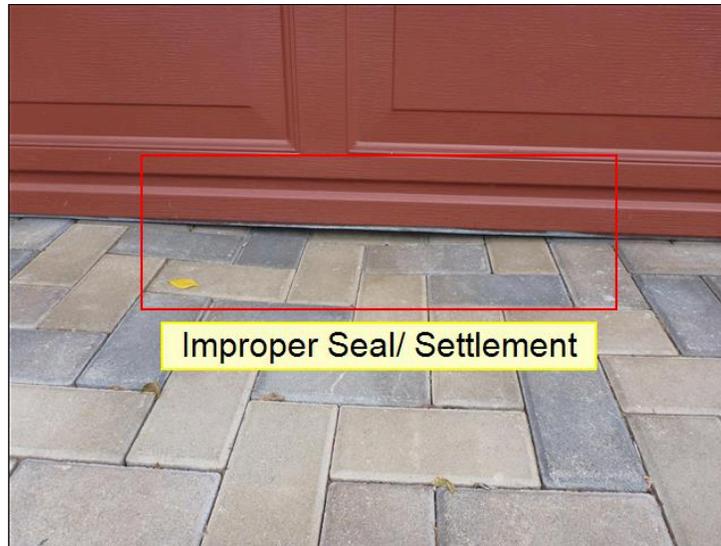
4.4 (See Picture(s))

Damaged lower panel noted at garage door. Repair/ replace as desired.(See Picture(s))

Settlement/ improper seal noted at garage door. Suggest installation of a rubber weather stripping strip on pavers. Consult a contractor for evaluation/ adjustment/ repairs as desired.(See Picture(s))

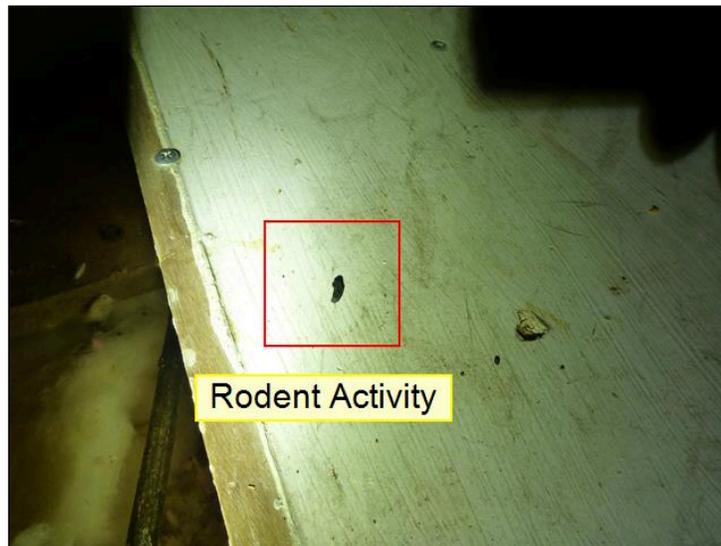
5.0 (See Picture(s))

Rodent activity noted in the attic. Consult a pest control professional for evaluation and remediation as required. (See Picture(s))  
No structural conditions to report in attic. See pest control report for conditions related to wood framing members.

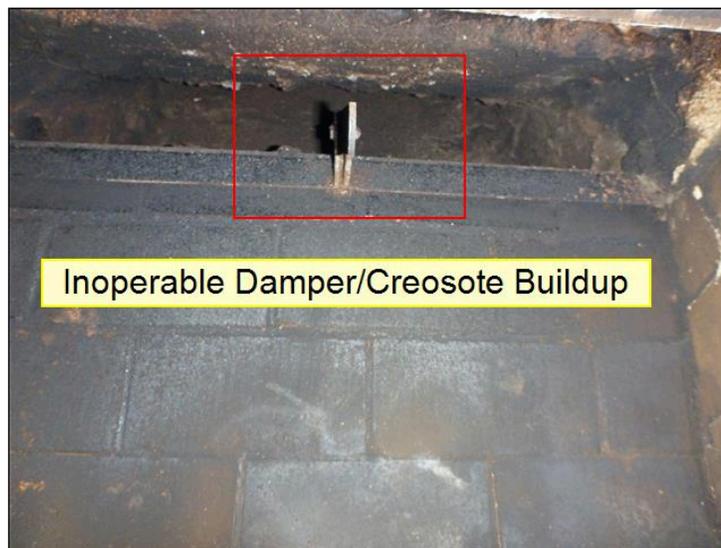
8.7 (See Picture(s))

Damper is stuck in the open position. Consult a chimney sweep for rain cap installation and lubrication/servicing/repair of damper for proper operation.(See Picture(s))

Creosote buildup noted. Consult chimney sweep for evaluation, cleaning, and have liner checked prior to use.

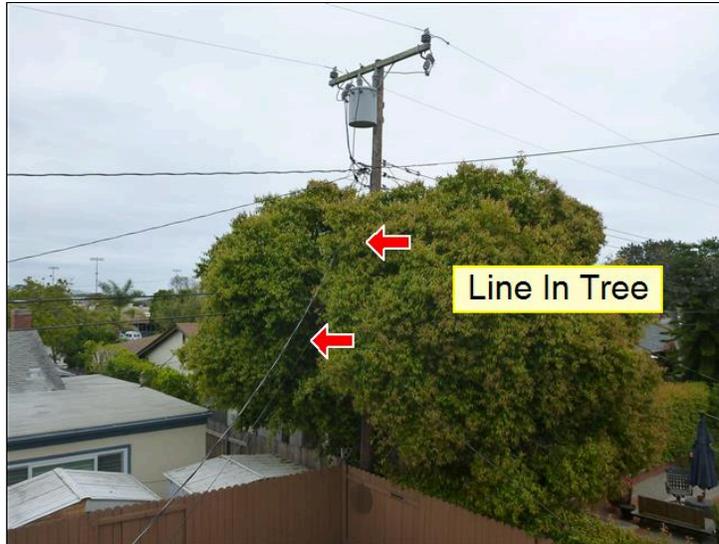
9.0 (See Picture(s))

Service wires are in tree and may be damaged by branches. Consult utility company to trim branches away from service wires to prevent damage.(See Picture(s))

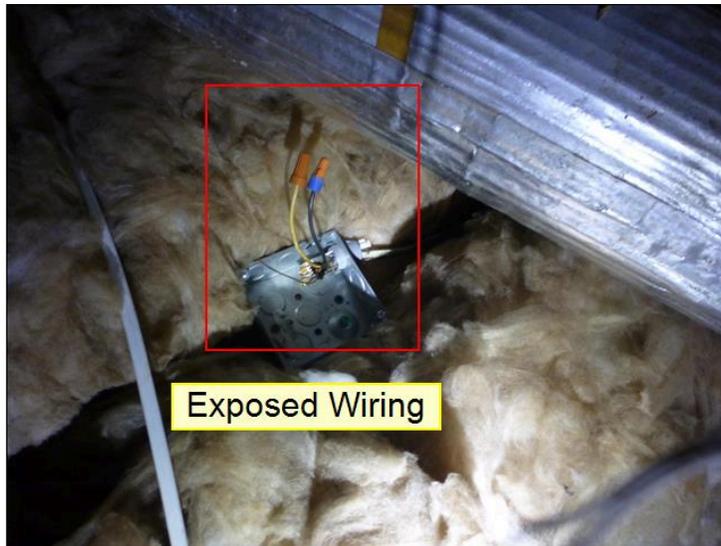
9.5 (See Picture(s))

Open junction boxes with exposed wiring noted in attic. Add cover plates at any/all open junction boxes and/or properly terminate wiring for proper and safe installation.(See Picture(s))

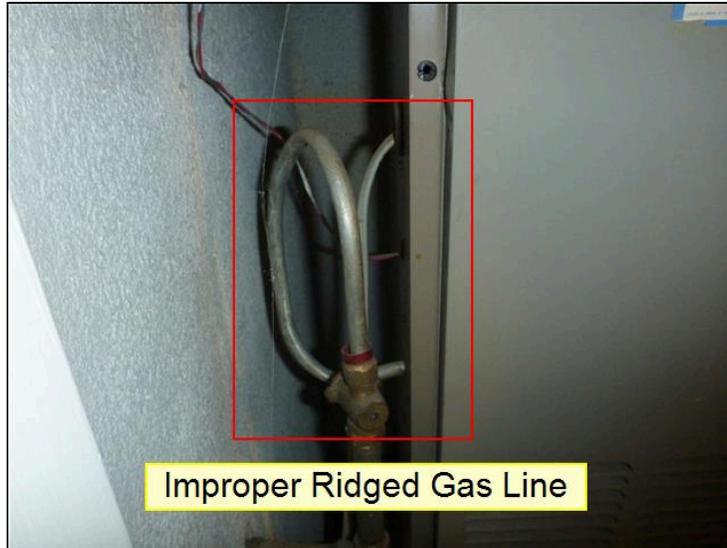
10.2 (See Picture(s))

Changing of current rigid gas piping to a modern/approved flexible gas line is needed for safety. Anticipate gas company red tag if not replaced. Consult a HVAC or plumbing contractor for replacement.(See Picture(s))

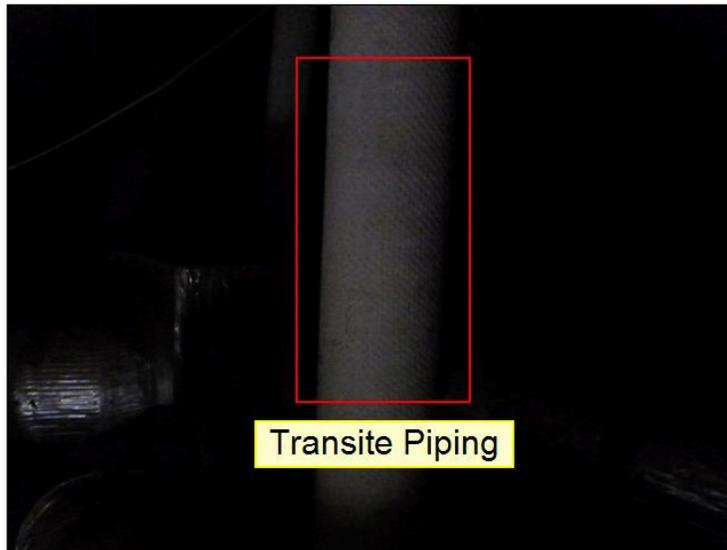
10.4 (See Picture(s))

Transite (asbestos materials) flue pipe should have been replaced when heater was replaced. Corrosion noted at metal portion of flue pipe. Suggest evaluation and repairs/replacement of flue pipe for proper and safe operation.(See Picture(s))

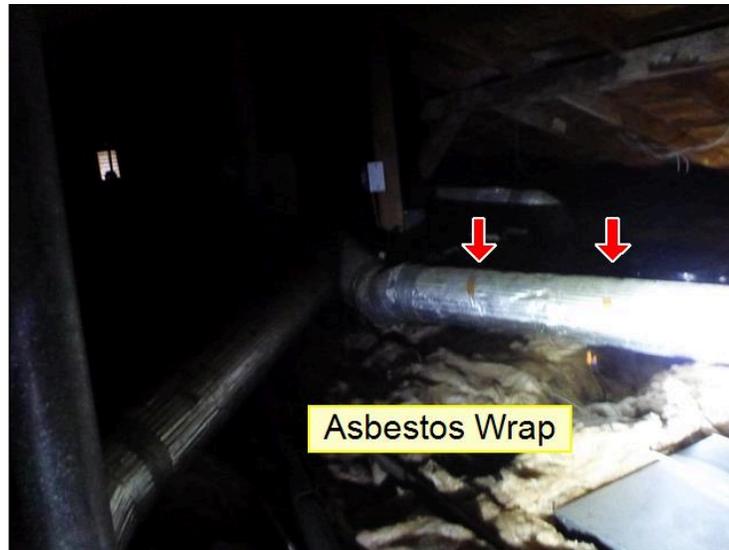
10.6 (See Picture(s))

Asbestos like material observed at heating system ducting in attic. Consult a HVAC contractor for repairs or replacement/abatement as required.(See Picture(s))

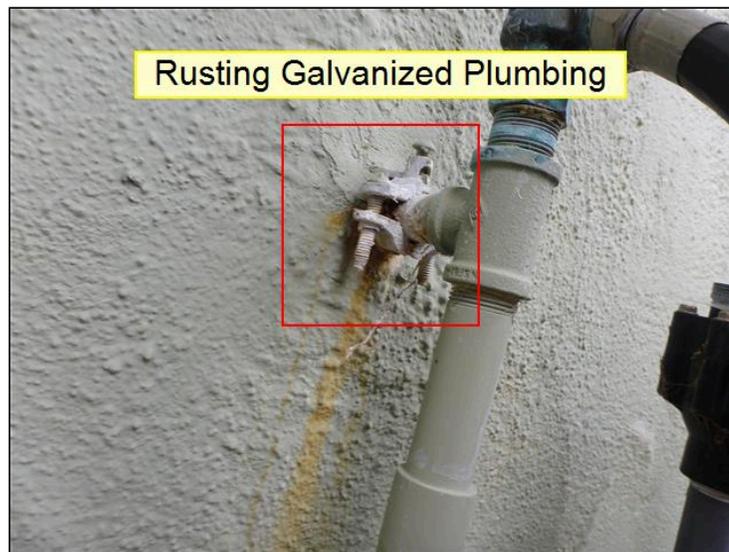
11.0 (See Picture(s))

Rust/ galvanized plumbing noted at exterior hose bibs. Monitor condition and anticipate replacement of remaining galvanized piping as needed.(See Picture(s))
